Manhole Inspection Summary

Manhole # S43E__036MH

Insp Date: **4/23/08 9:06 AM**

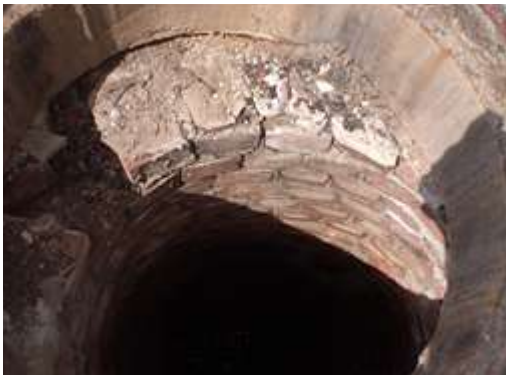
Defect 2

Condition: ☐ Sound ☐ Cracked ☐ Root Intrusion ☒ **Loose Brick** ☒ **Deteriorated**

Loose Bricks

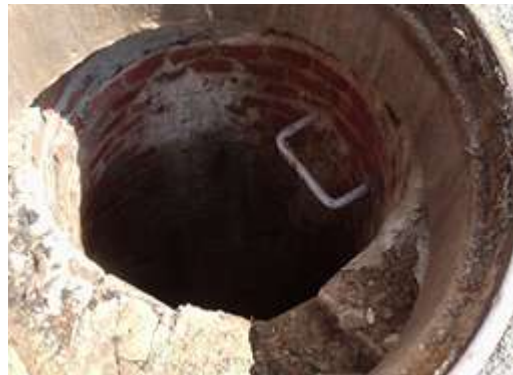
Defect 1

Frame Offset: **7** (in.) Condition: ☒ Sound ☐ Cracked ☐ Leaks

Deterioration, Offset Frame

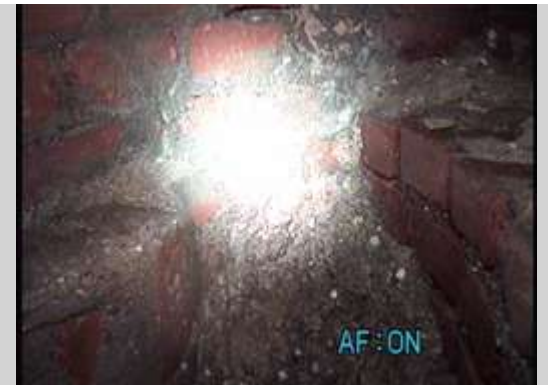
Pipe In @ 3 O'Clock

capped at 6 oclock

Connects To: **Stub connection / abandoned**

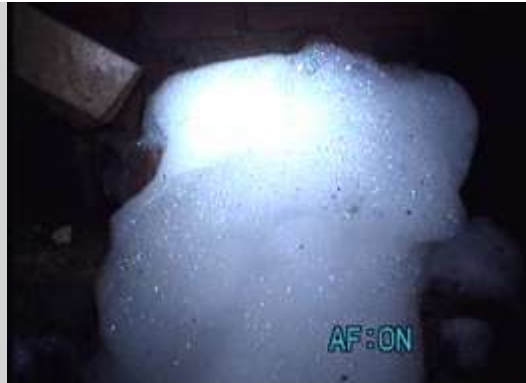
Pipe In @ 6 O'Clock

soap suds in the way
